METHODOLOGY FOR COATED INFRASTRUCTURE INSPECTION BY MOBILE POTENTIOSTAT

Bobbi Jo Merten, Ph.D.¹, Susan Drozd, PCS², Cassidy Gills³,
David Tordonato, Ph.D., P.E.¹, Jeff Ryan²

¹Bureau of Reclamation, Lakewood, CO, USA

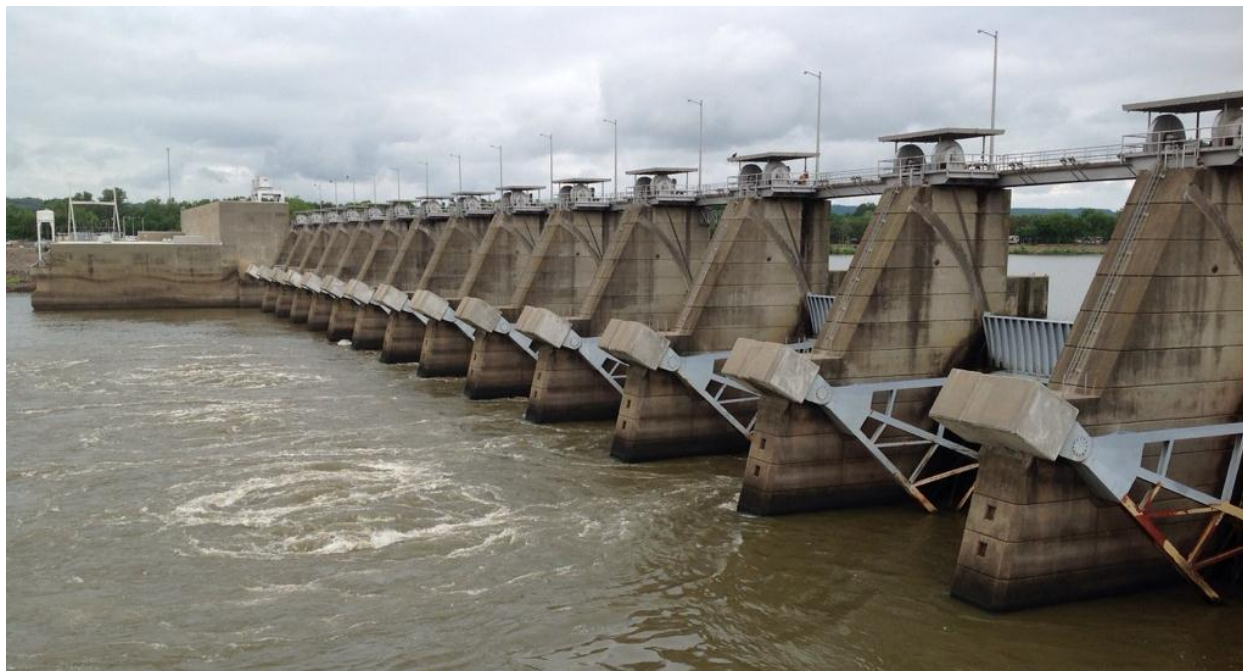
Figure 1. Ozark-Jeta Taylor Lock and Dam location for inspection with mobile potentiostat

The initial step in this inspection is to assess the coated steel for coating material, condition, service/exposures, and access. Figure 1 provides one USACE facility utilized for this demonstration. The top and upstream faces of the radial gate provided opportunities for experimentation. At a second USACE facility, tests were conducted on a trunnion arm near the pin, handrail structural brackets, and the upstream vertical face of the lock miter gate. Table 1 details test sites and conditions. Note that Test 2.2 had one visible defect in the test cell.

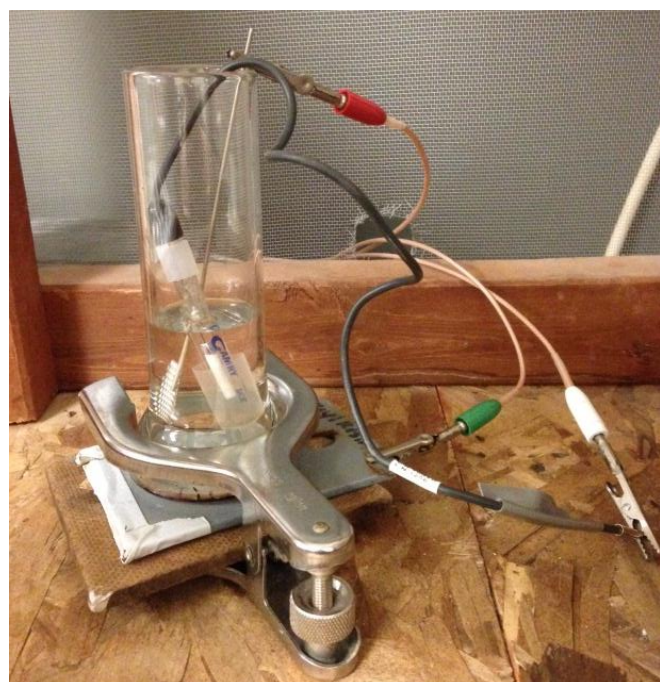
Figure 2. Laboratory EIS test cell in Faraday cage

The panel was prepared for EIS measurements in the following manner: a glass cylinder was clamped to the coated panel and sealed using an *O*-ring to prevent leakage. DHS solution was added to the glass cylinder. The reference electrode and counter electrode were also placed inside the test cell. A saturated calomel electrode (SCE), platinum mesh, and steel substrate were used and the reference, counter, and working electrode, respectively. Refer to Figure 2 for this test cell set up.

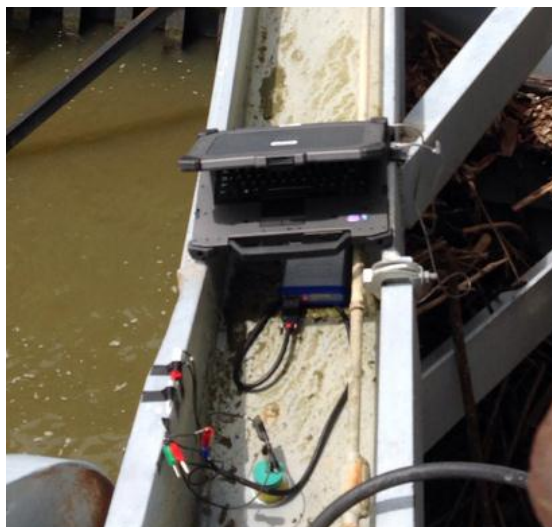
Figure 5. Field EIS Test 2.2 set-up (left) and results (right) for USACE Tainter gate at trunnion arm

Test 2.2 measured a horizontal surface on the Tainter gate arm, near the trunnion pin. Figure 4 provides the test setup and data. This coating contained standing water due to a plugged drain hole. The drain was cleared and the water removed to evaluate the coating. Afterward small rust stains indicated numerous pinhole defects in this test area. One defect was isolated in the test cell. The defect was not measured but is estimated to be less than 1 mm^2 .

The $|Z|_{0.01 \text{ Hz}}$ measured $10^7 \Omega$ for Test 2.2. The test was set up to measure 5 data points per decade, resulting half the data points. The resulting data shows minimal scatter and is sufficient to conclude that the test results are accurate and realistic. Using the colored strip, this coating is currently providing adequate corrosion protection. Taking the pinhole into consideration, which provides a low resistance pathway, the coating film is in good condition.

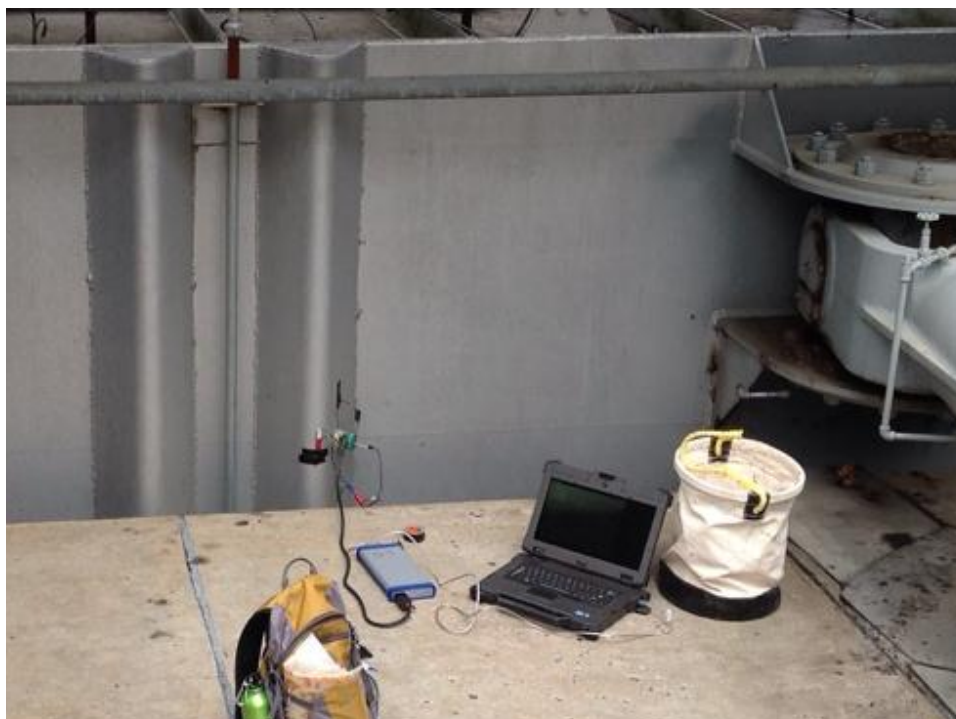
Figure 6. Field EIS Test 2.3 set-up on upstream face of miter gate

Test 2.3 measured a vertical surface on the upstream face of the miter gate (Figure 5). The instrument terminated the measurement before completing due to resistances exceeding the instrument's capacity. A poor substrate connection was attributed to this, and, therefore, no coating data is available.
